# **Enhancing Reef Recovery in Komodo National Park, Indonesia: Coral Reef Rehabilitation at Ecologically Significant Scales**

INTERIM REPORT: Project Installation

Helen Fox  
Christine L. Huffard

May, 2002

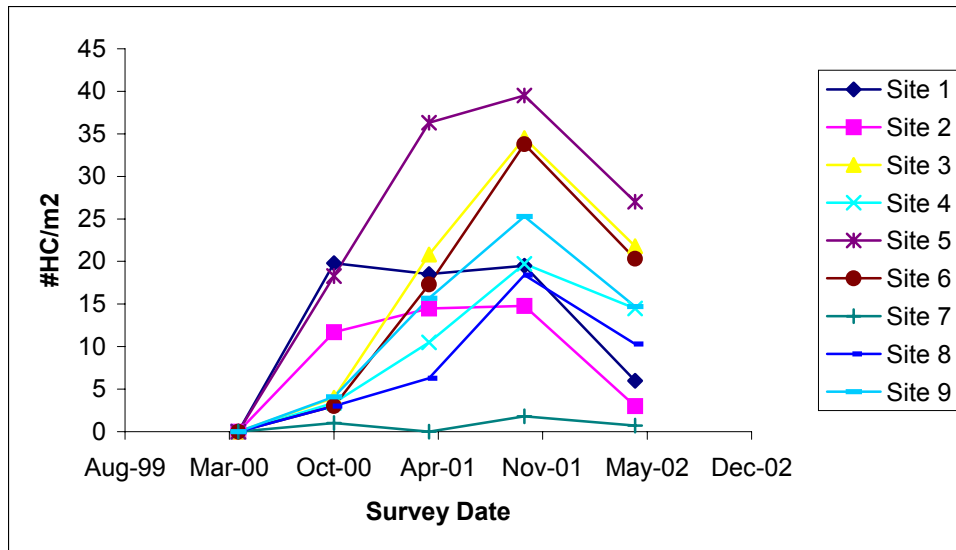
Rock piles installed in Spring 2000 at nine rubble fields have been monitored twice yearly for hard coral (HC) and soft coral (SC) growth (Figure 1). This trip, an average of 13 coral colonies/m<sup>2</sup> were recorded, ranging from 1 HC/m<sup>2</sup> where soft coral growth is extensive along northern Rinca (Site 7), to 27 HC/m<sup>2</sup> along Karang Makassar (Site 5). Decrease in numbers of HC at Sites 1 and 2 is probably due to increased *Xenia* cover. The rocks at Pulau Mengyatan (Site 2) are also nearly buried by sand, and only two square meters of one pile are visible. Although the total number of hard corals has dropped at all sites since the last survey in October 2001, the sizes of the existing coral colonies appear to be increasing, so the overall percent cover of hard coral colonies is increasing. Sites chosen for large-scale rehabilitation have an average of 20 HC/m<sup>2</sup>, which is considerably higher than the ambient recruitment to nearby rubble fields (4 HC/m<sup>2</sup>). After only two years, ecologically and economically important fish and invertebrates such as grouper, *Trochus*, and *Octopus cyanea* have inhabited these piles.

**Figure 1.** Average numbers of scleractinian recruits per square meter to large (0.5-2m<sup>2</sup>) rock piles within the first two years based on six 1x1 m quadrats at each of nine rubble field sites in Komodo National Park. For site locations see Figure 1 in the December 2001 report.

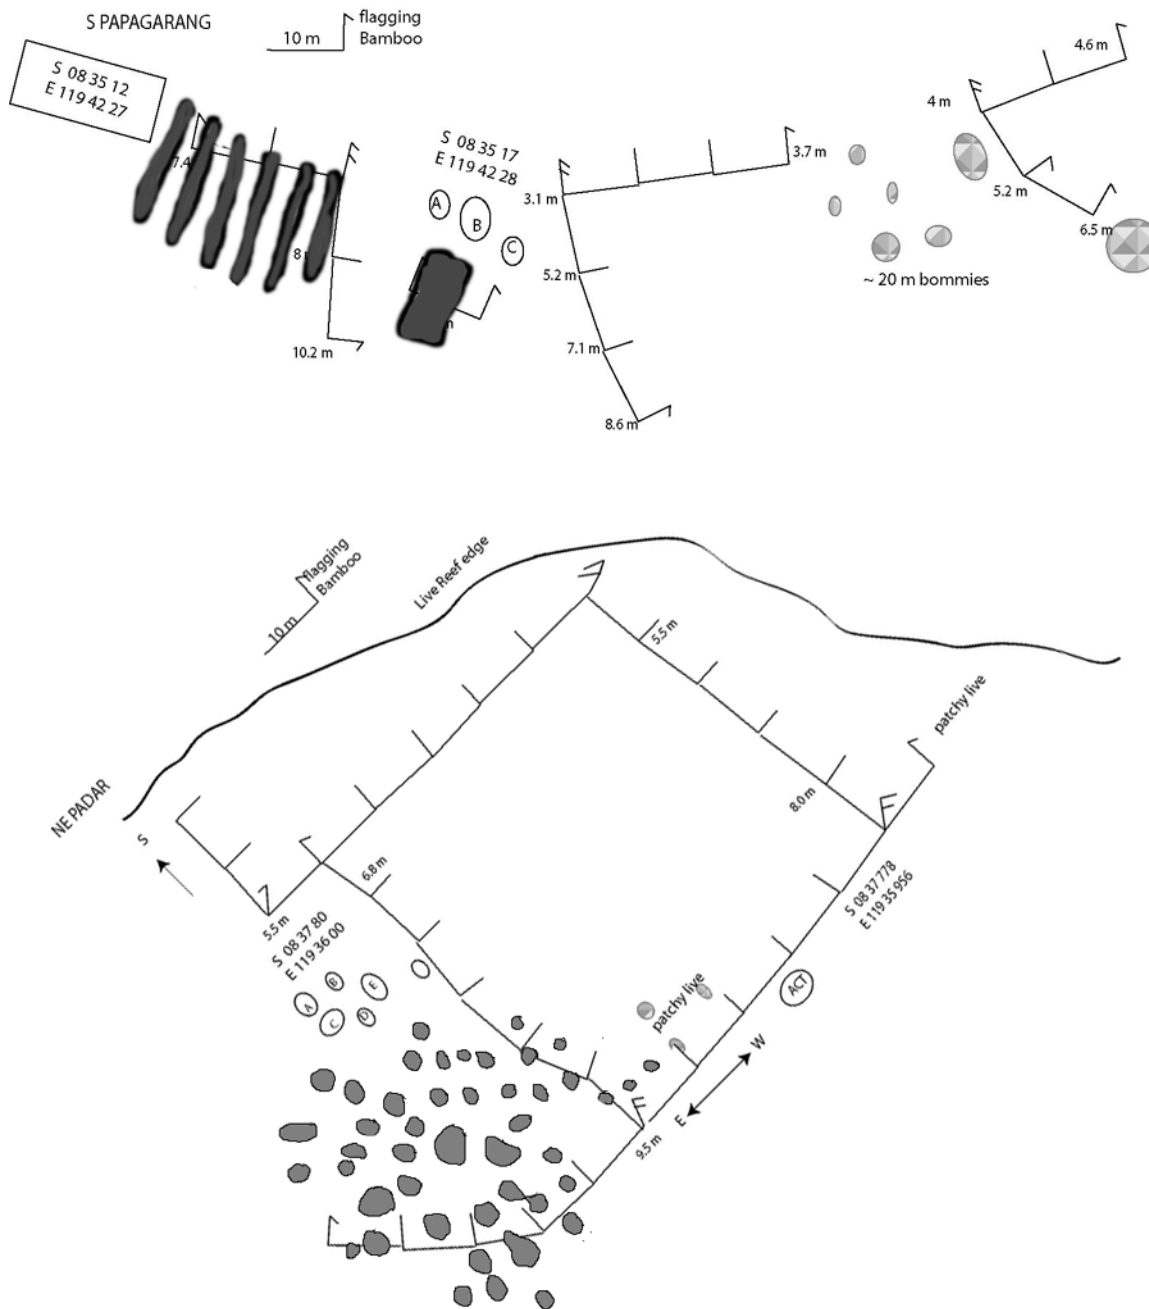
Maps of rocks installed (except perpendicular rows at Padar) have been prepared to monitor both initial placement as well as integrity of shape once established (Figures 2 and 3). A map of the rows perpendicular to the current at Padar was not prepared because of time constraints and because the rows may be shifted. Close-up figures that include specific dimensions of rocks appear at the end of this text as Appendices.

Figure 2. Rocks already installed Papagarang (top) and Padar (bottom- missing rock rows perpendicular to the current) by May 2002. Please see Appendix 1 for close-up views and dimensions.

“Completed” treatments installed so far are smaller than target coverage and have received fewer than the 60-70 allotted truckloads of rocks (Table 2). Rows are shorter and piles are fewer than planned. Installation priority should be given to completing these arrangements as soon as possible to minimize damage to the new colonizing community. Timely installation is also necessary so that colonization rates can be monitored consistently.

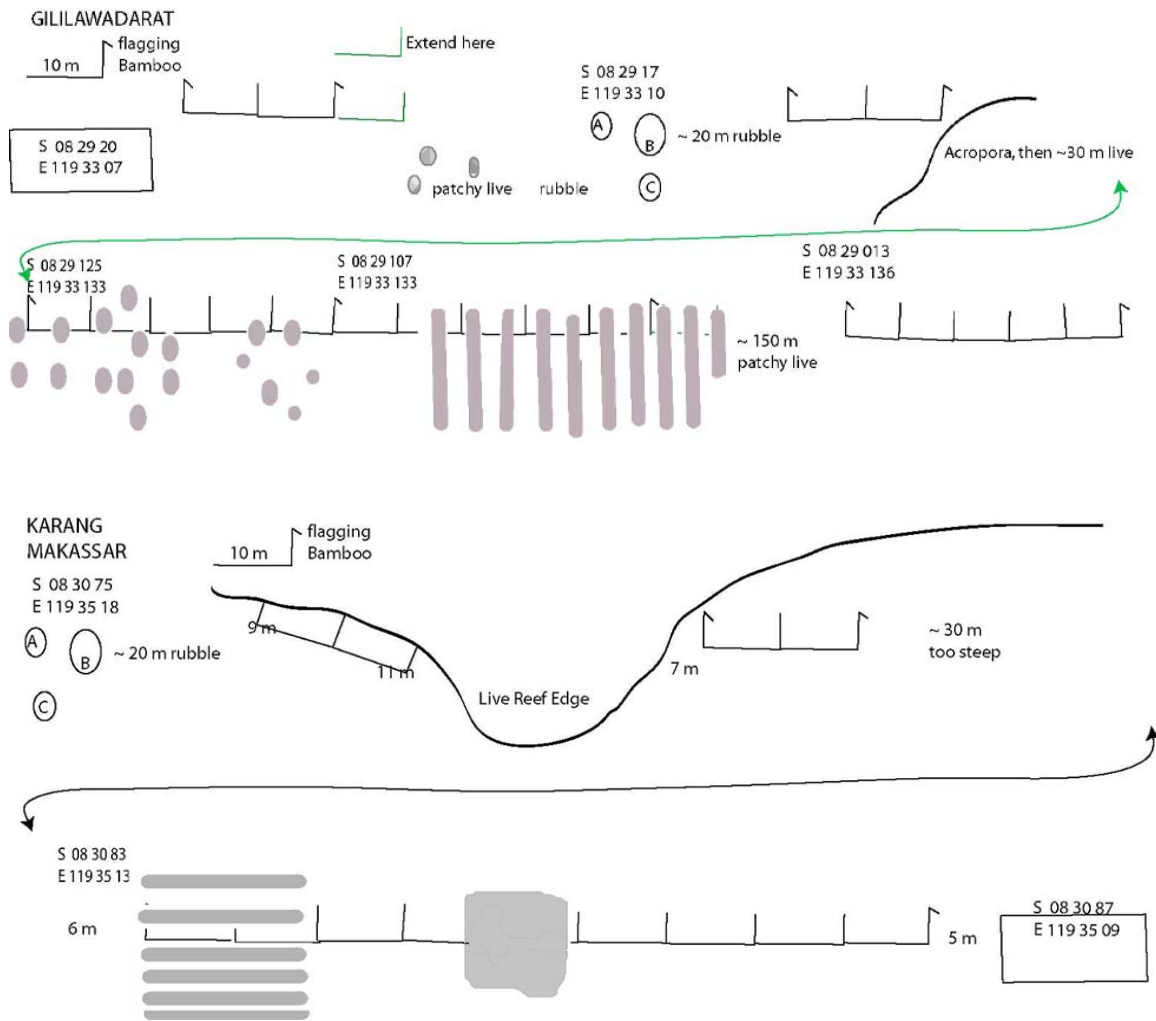
At Karang Makassar, the deepest rows of rock parallel to the current have already started to merge together. The heavy treatment appears to be sliding on the unstable rubble down the steep slope, and it will be interesting to see whether or not the rocks form a large stable row at some point. However, at Gililawadarat, the rows perpendicular to the current extend down a steep slope to 30 feet and appear to be maintaining shape. All configurations on slopes should be mapped on a regular basis, perhaps once or twice a year, with particular attention to depth.

Figure 3. Rocks already installed at Gililawadarat (top) and Karang Makassar (bottom) by May 2002. Please see Appendices 2-4 for close-up views and dimensions.

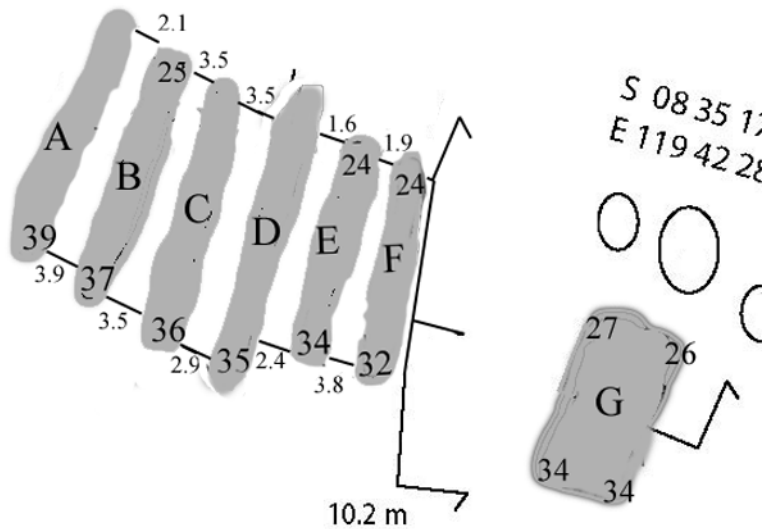
Appendix 1: Papagarang: Rows or rocks perpendicular to prevailing current and complete rock coverage. All treatments here are between 0.75-1m high.

Figure 3.1: Close-up map of rows and complete coverage showing distances (m) between rows and depth

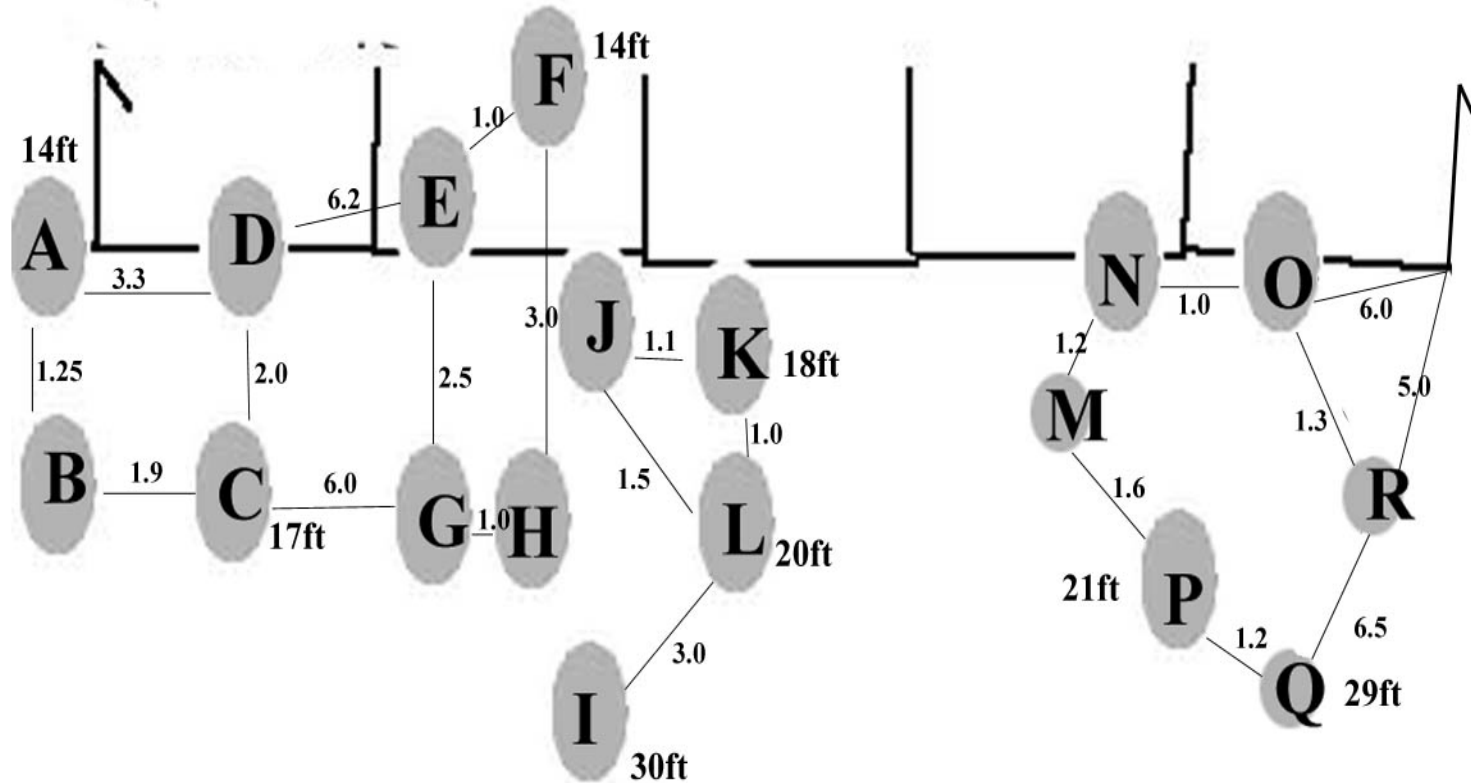
Appendix 2: Gililawadarat Rock Piles (batu gunung)

Figure 2.1: Close-up map of rock piles showing distances (m) between rock piles and depth

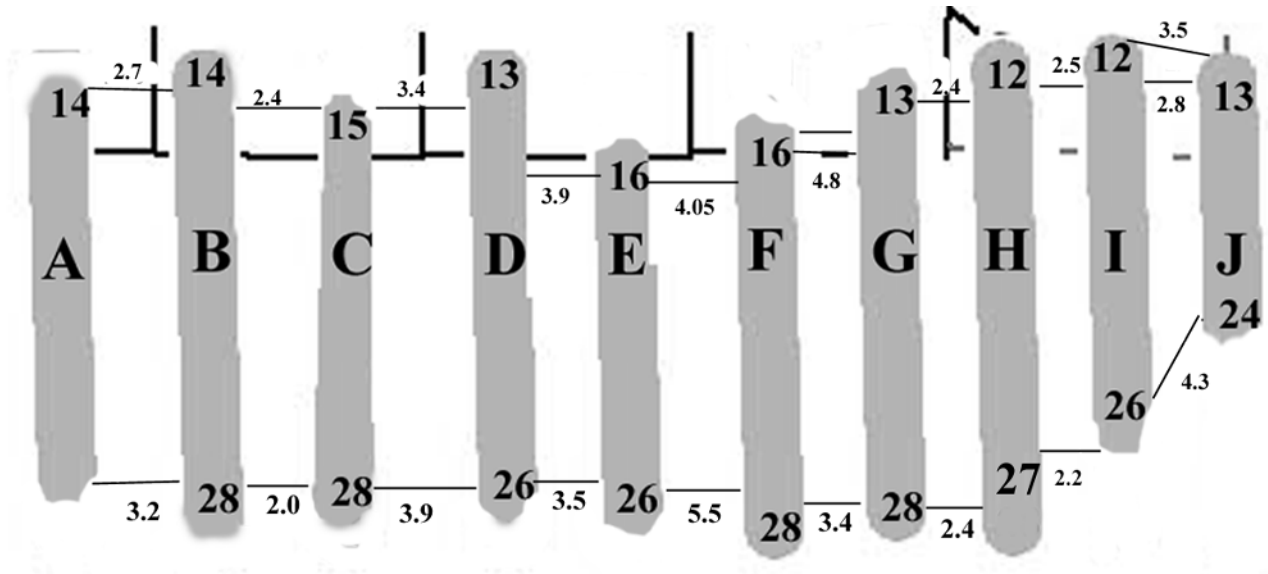
Appendix 3: Gililawadarat Spur and Groove Perpendicular to the prevailing current

Figure 3.1: Close-up map of rows of rocks. Depths (large numbers at the top and bottom of rows) and distances (m) between rows are shown.

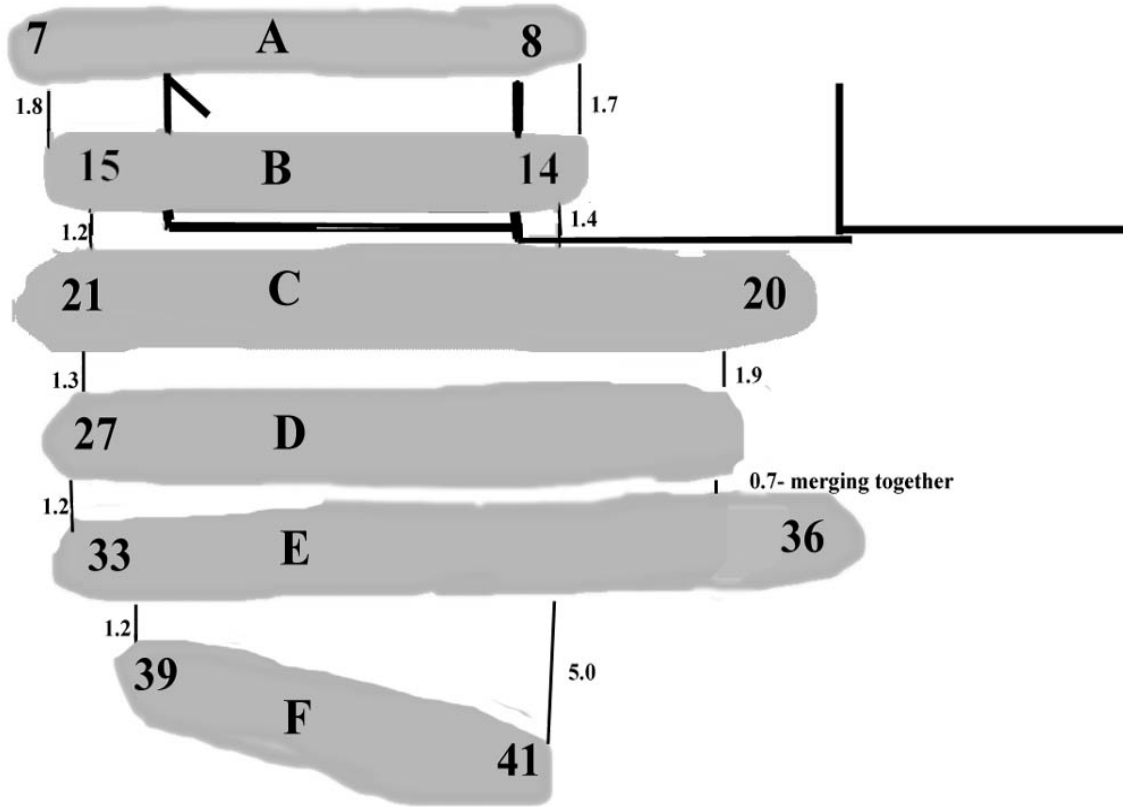
Appendix 4: Karang Makassar Groove and Spurs parallel to current.

Figure 4.1: Close-up map spurs showing distances (m) between rock piles and depth (ft)

Complete coverage is: 8.9-10.4m wide, 9-11m long, 0.4-0.9m tall
